# DUE DILIGENCE GEOTECHNICAL ASSESSMENT

**St. Katherine of Alexandria Orthodox Church**  
**1690 Via Cancion, San Marcos, California 92078**

NOVA Project No. 2023084  
July 21, 2023

Subject: Due Diligence Geotechnical Assessment  
St. Katherine of Alexandria Orthodox Church  
1690 Via Cancion  
San Marcos, California 92078

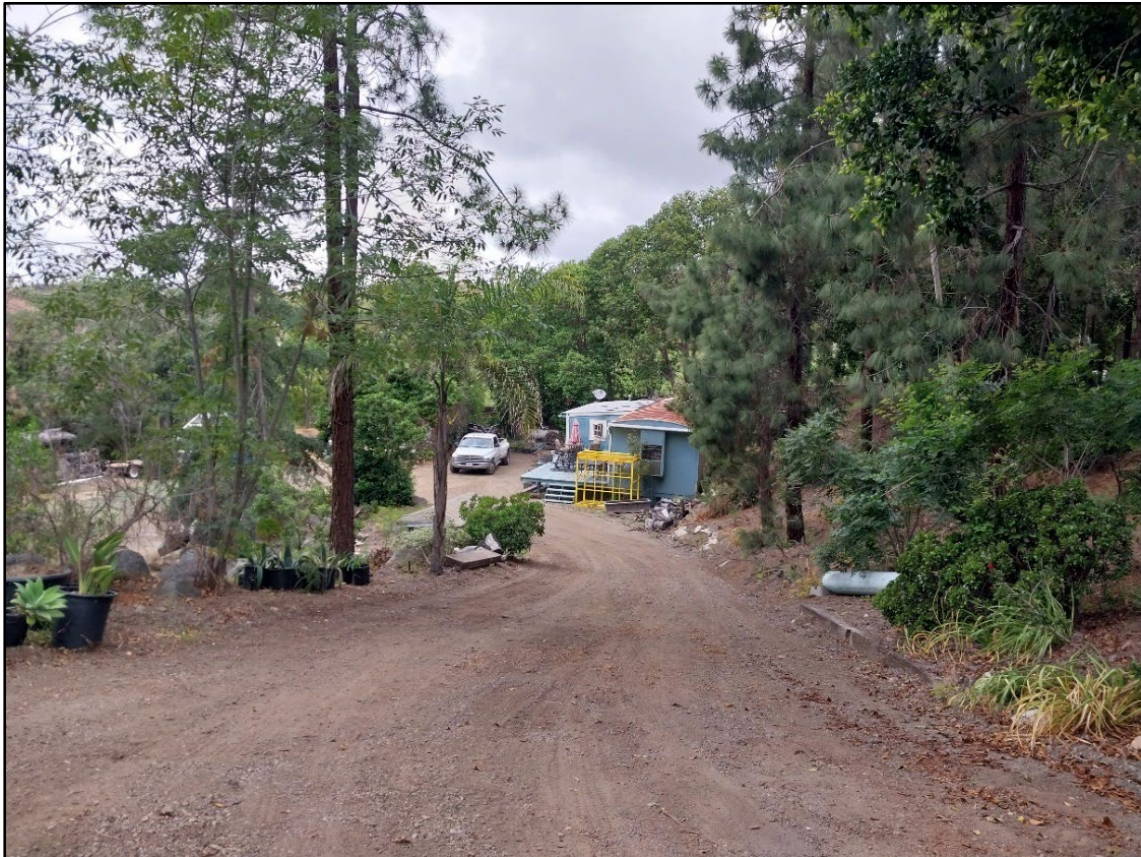
Figure 3-1. Existing, Middle of Site, May 2023

The site is currently occupied by various structures such as a mobile home, storage buildings, a cellular tower, and concrete ponds/waterfalls. The site is currently being used as a nursery and equipment yard for a landscaping business. Figure 3-1 through Figure 3-3 present views of the site conditions existing in May 2023.

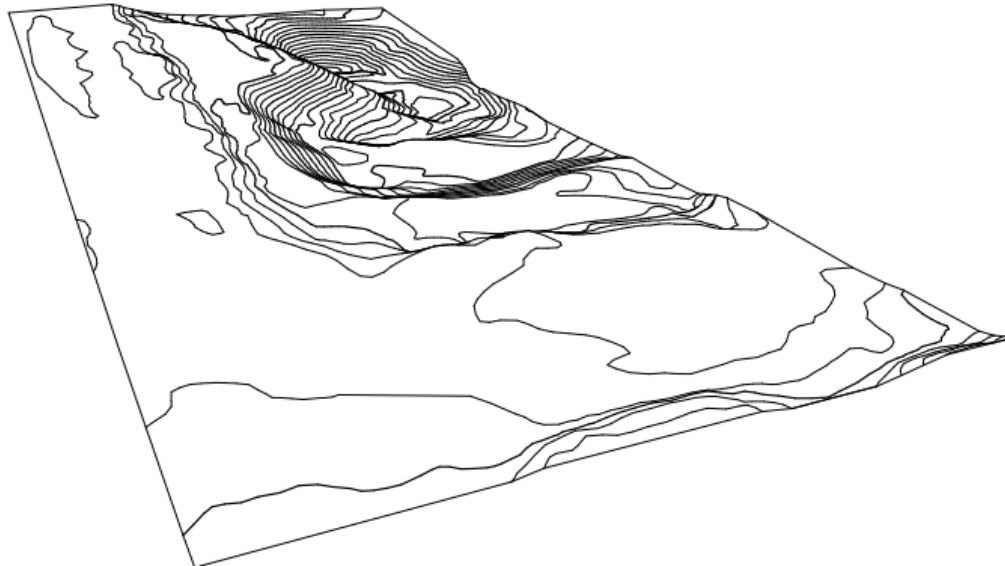
**Figure 3-4. Site Topography, View to the Southwest**  
(source: CTA 2023, Figure A1.1)

The northern portion of the site has three terraced pads that are relatively flat, which descend to the south. The northern pad is at approximately 504 feet mean sea level (msl), the middle pad is at approximately 498 feet msl, and the southern pad is at approximately 480 feet msl. Along the eastern margin of the site is an access road that becomes narrow in the center and widens out at the southern portion of the site. This road is around 500 feet msl in the southern portion of the site. West of this access road and south of the lowest pad, the topography descends into the pre-existing canyon. The lowest point of the site is at an elevation of approximately 460 feet msl. Figure 3-4 depicts the topography described above.

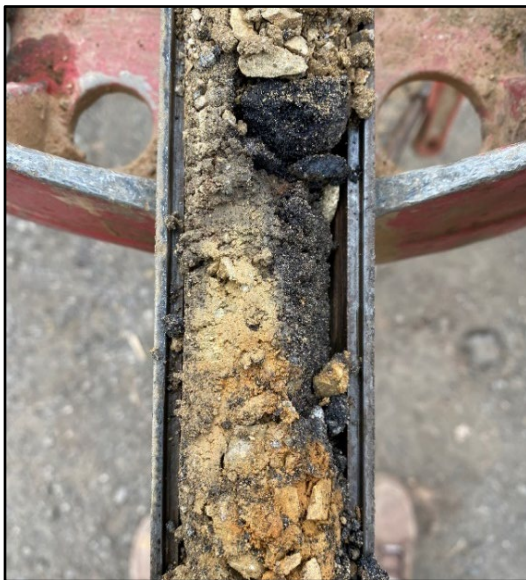
Figure 4-2. Fill in Boring B-1

**Undocumented Fill (af):** Fill was encountered in each of the borings to depths between about 12 and 26½ feet bgs. As encountered in the borings, the fill is heterogeneous, containing zones of loose to medium dense clayey fine sand, medium dense to dense poorly graded gravel, and soft to very stiff sandy lean clay and sandy fat clay. Concrete fragments and roots were encountered in some samples. NOVA has no records regarding the placement and compaction of the fill; therefore, it is considered 'undocumented' and at risk for the wide variations in quality and consistency that were observed in the samples from the borings.

This fill encountered is not considered suitable in its existing condition for support of the proposed structures. Figure 4-2 and Figure 4-3 depict the fill encountered in Borings B-1 and B-2.

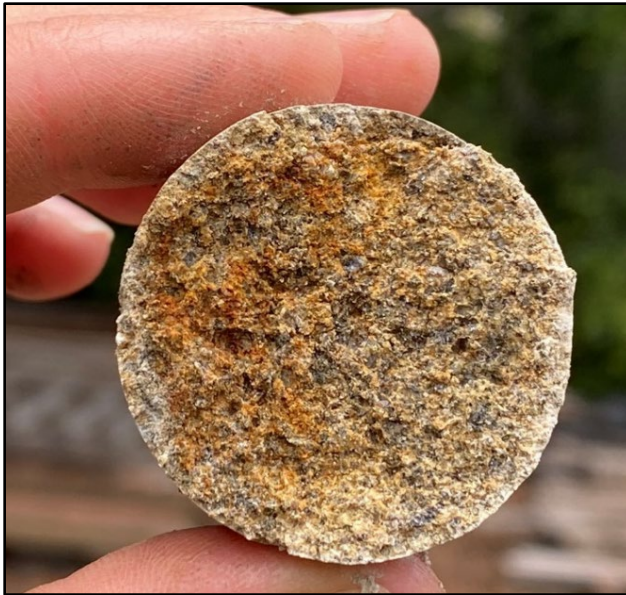
Figure 4-4. Formational Rock in Boring B-3

**Mesozoic Metasedimentary and Metavolcanic Rock, Undivided (Mzu):** The metasedimentary and metavolcanic rock was encountered beneath the fill in Borings B-1 through B-5, to the maximum-explored depth up to about 27 feet bgs. As encountered in the borings, the rock generally consisted of dense to very dense silty and clayey sandstone and hard sandy siltstone. Figure 4-4 and Figure 4-5 are photographs of the formational rock encountered in Borings B-3 and B-4.
