# DUE DILIGENCE GEOTECHNICAL ASSESSMENT

**St. Katherine of Alexandria Orthodox Church**  
**1690 Via Cancion, San Marcos, California 92078**

NOVA Project No. 2023084  
July 21, 2023

Subject: Due Diligence Geotechnical Assessment  
St. Katherine of Alexandria Orthodox Church  
1690 Via Cancion  
San Marcos, California 92078

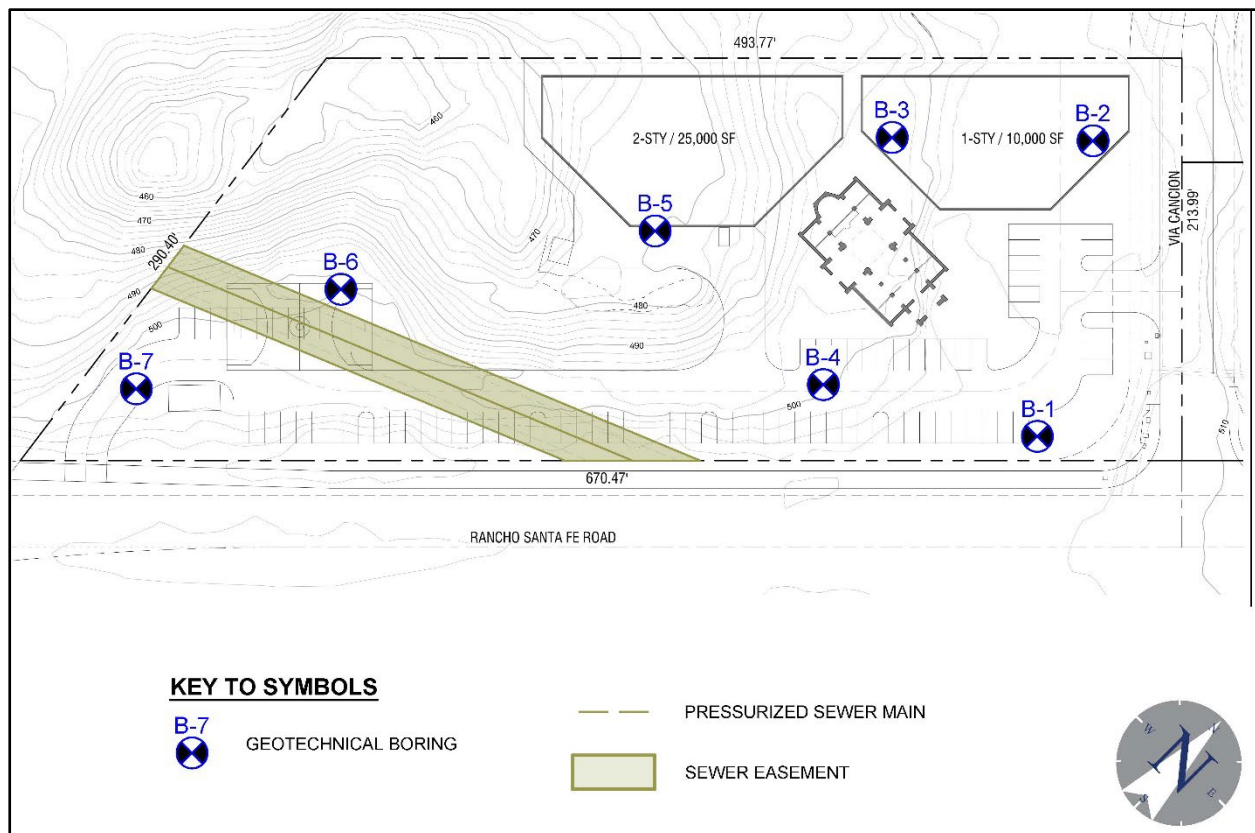
**Figure 2-1. Subsurface Exploration Map**

The subsurface exploration consisted of drilling seven geotechnical borings (B-1 through B-7) to depths up to 27 feet below the ground surface (bgs) using a truck-mounted drill rig equipped with a hollow-stem auger. Borings B-6 and B-7 did not advance past 2 feet bgs due to drill refusal on large boulders within the rock fill located the southern portion of the site. Boring relocation of B-6 was not possible due to the easement for a pressurized sewer line and obstacles pertaining to the operation of the existing plant nursery. Boring B-7 was re-attempted multiple times, with refusal encountered each time. Figure 2-1 presents the approximate locations of the borings and the alignment of the sewer easement.

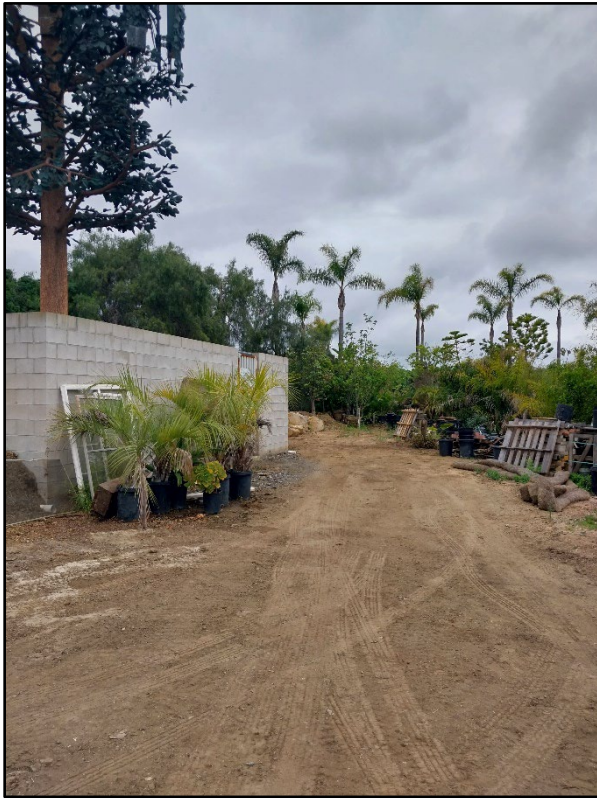
**Figure 3-2. Existing, SW End of Site, May 2023**

The site is currently occupied by various structures such as a mobile home, storage buildings, a cellular tower, and concrete ponds/waterfalls. The site is currently being used as a nursery and equipment yard for a landscaping business. Figure 3-1 through Figure 3-3 present views of the site conditions existing in May 2023.

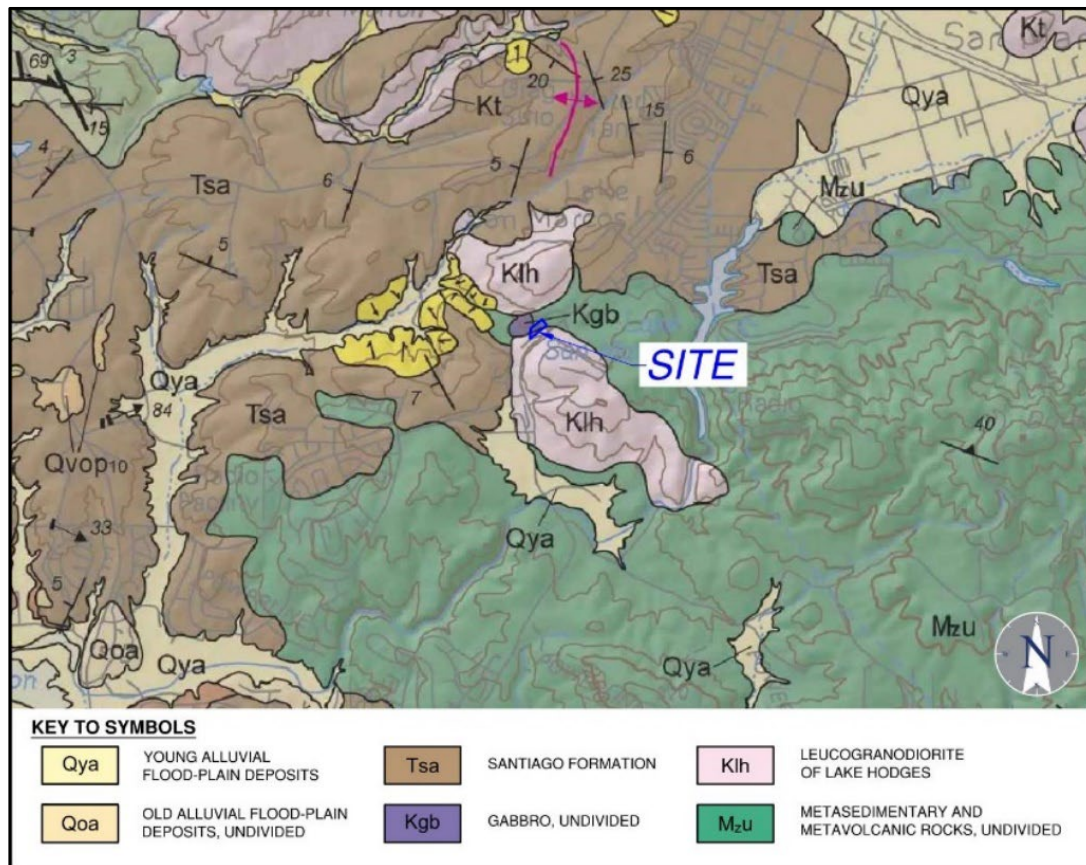
**Figure 4-1. Regional Geology Map**

Regional geologic mapping indicates the site is underlain by Mesozoic metasedimentary and metavolcanic rocks, undivided (Mzu), and possibly mid-Cretaceous leucogranodiorite of Lake Hodges (Klh) along the southern portion of the site, though this unit was not encountered in our borings. For the purpose of this report, NOVA assumes the whole site is underlain by Mzu. Figure 4-1 presents the regional geology in the vicinity of the site.

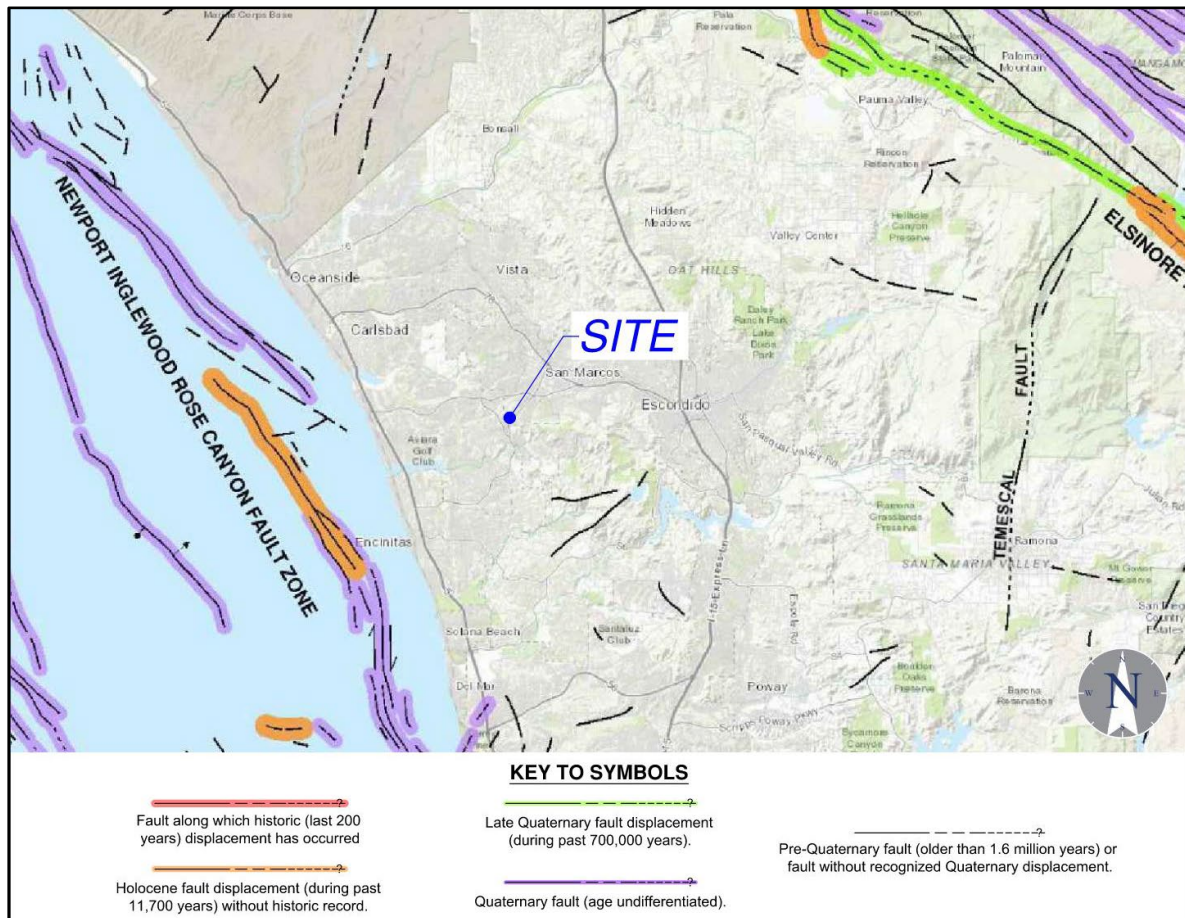
**Figure 5-1. Regional Faulting in the Site Vicinity**  
 (Source: Fault Activity Map of California – California Geological Survey)

The site is not located within a designated Alquist-Priolo Earthquake Zone. No known active faults are mapped below the site area, nor did geologic reconnaissance reveal any surface evidence of faulting. The nearest active fault is the Oceanside section of the NIRC, located about 8.7 miles to the southwest.

Due to the lack of active faulting, the probability of fault rupture at this site is considered very low. Figure 5-1 reproduces mapping of regional faulting in the site vicinity.
